# Situation Photo Log

Thursday, March 29, 2012

Kalamazoo River / Enbridge Spill

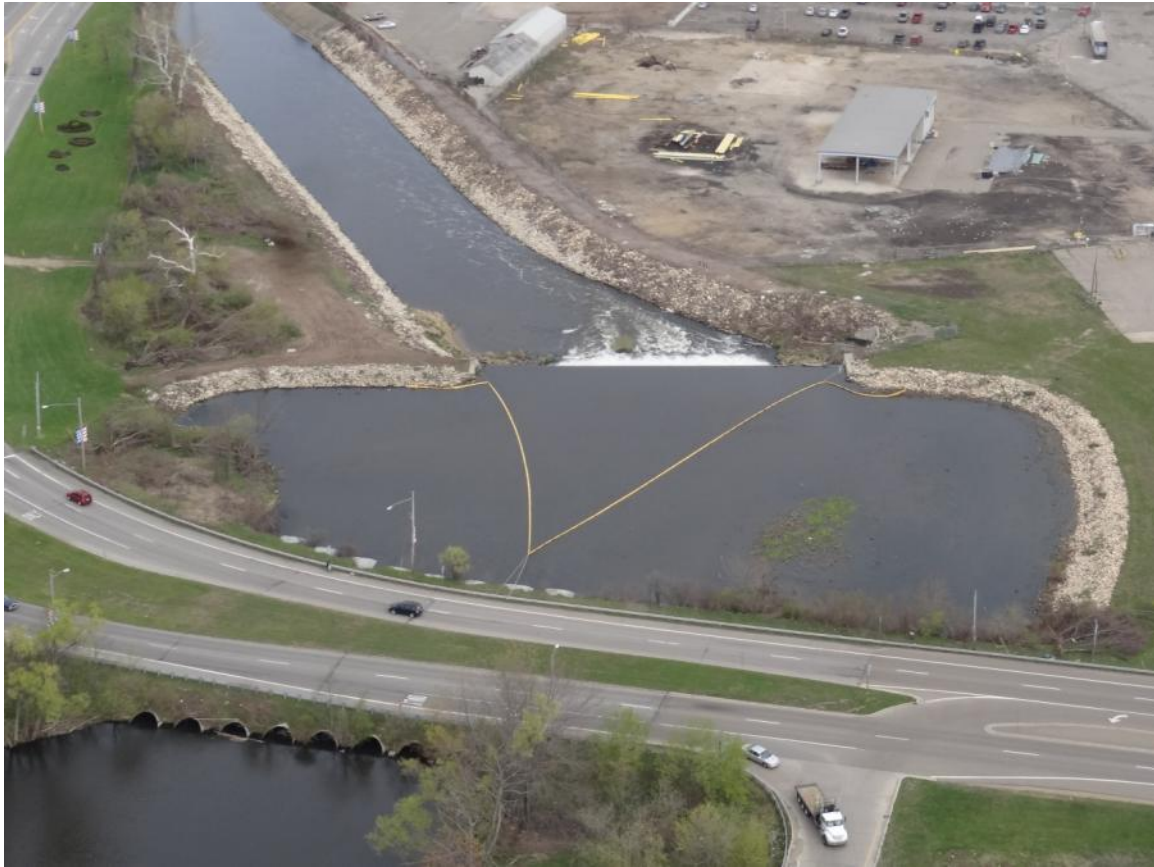
23. MP15.75 no sheen observed at the boom location.

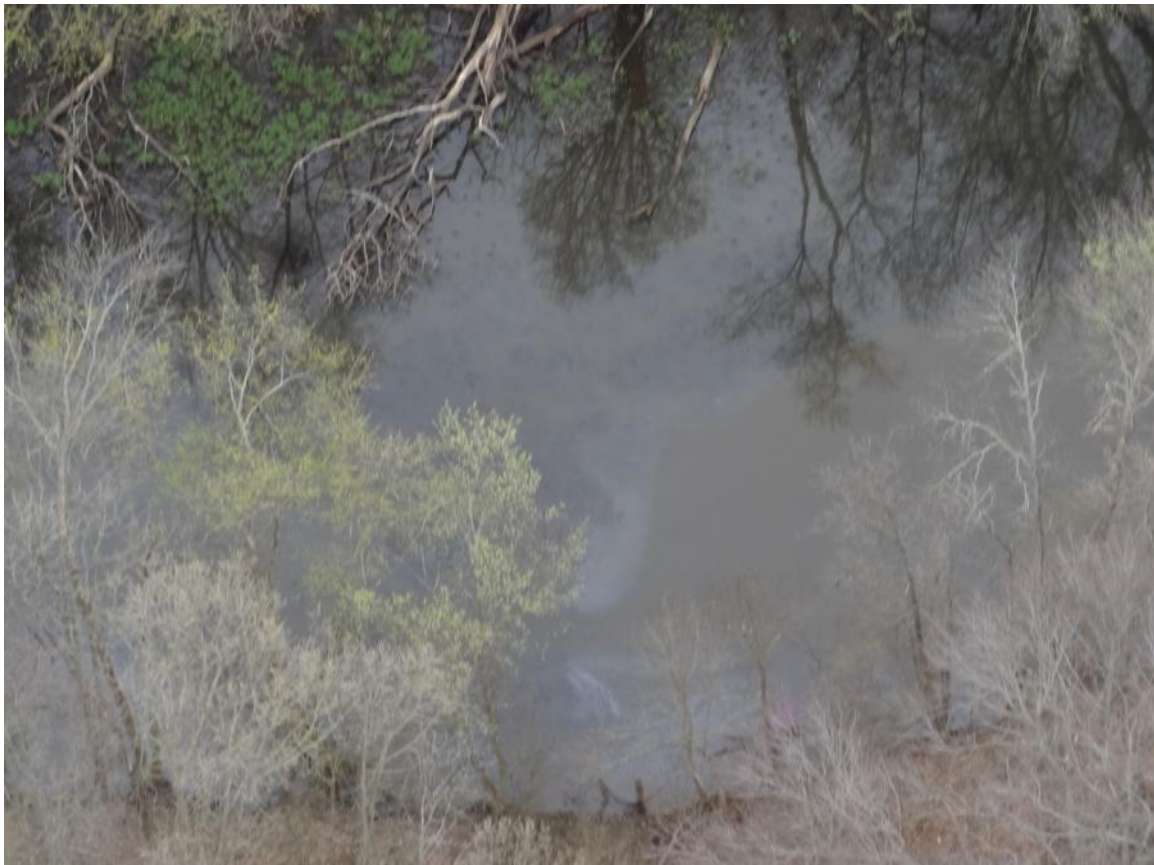
24. MP22.25 RDB sheen observed in former STRIKE site.

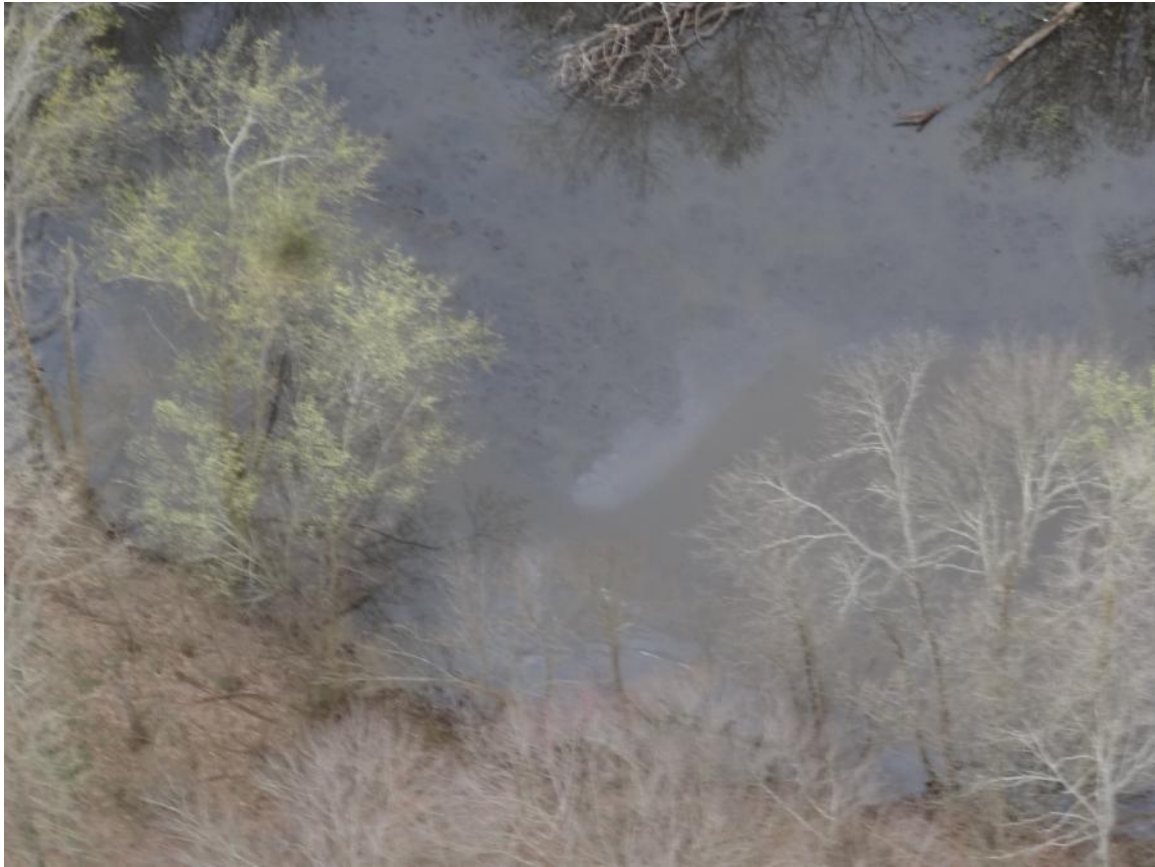
25. MP22.25 RDB sheen observed in former STRIKE location.

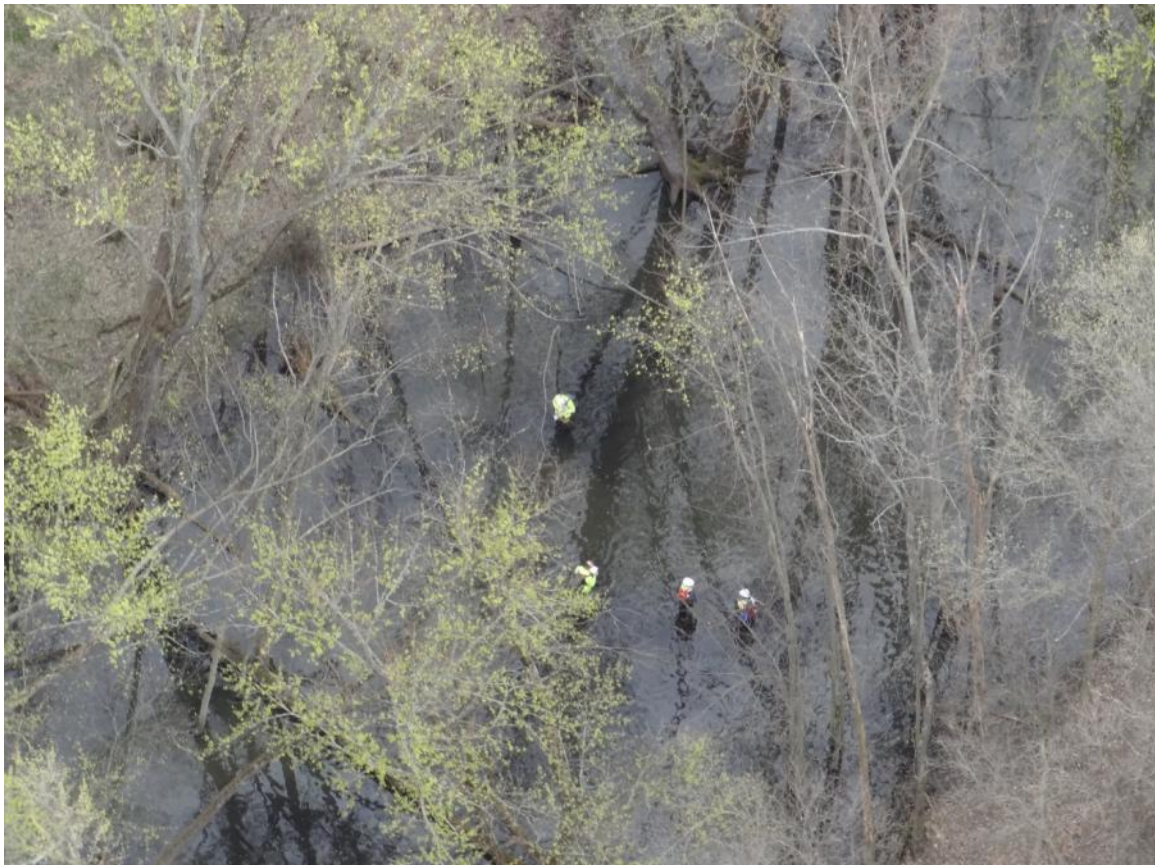
26. MP23.75 SORT crew observed.

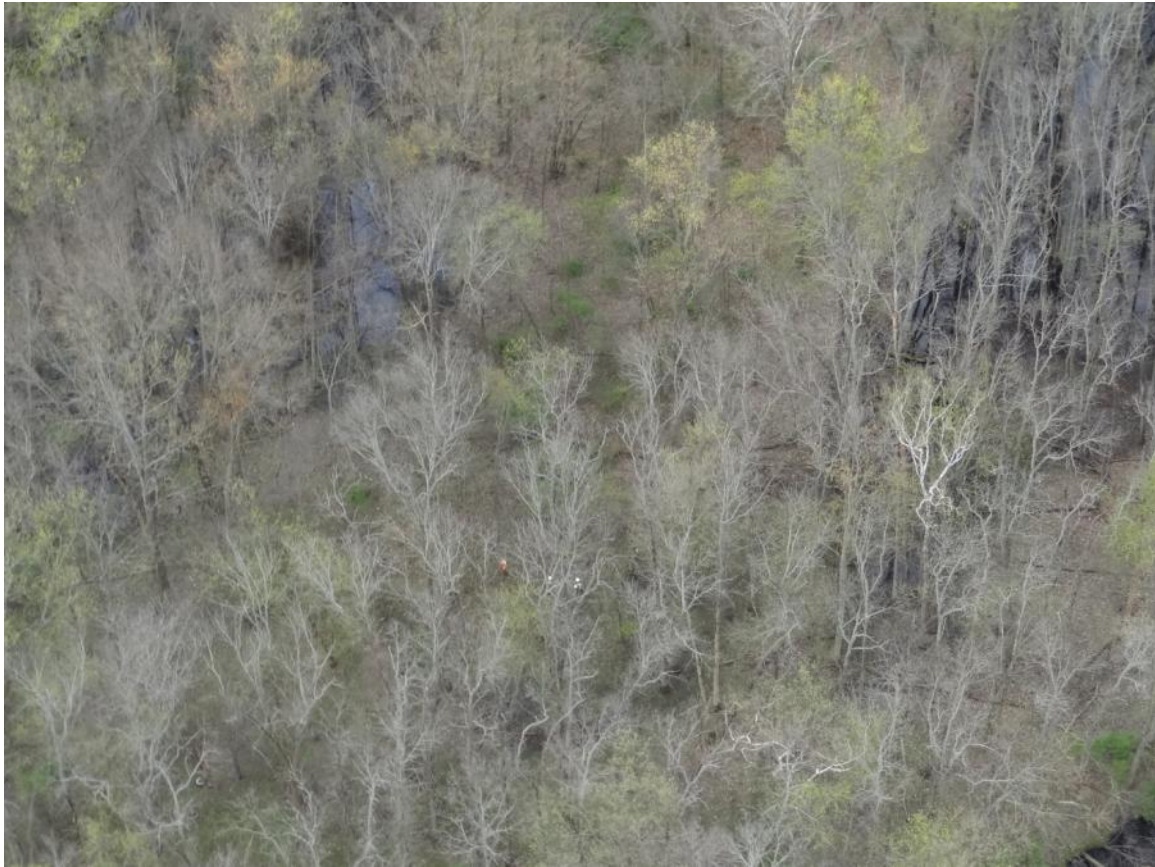
**27. MP29.0 SORT crew observed.**

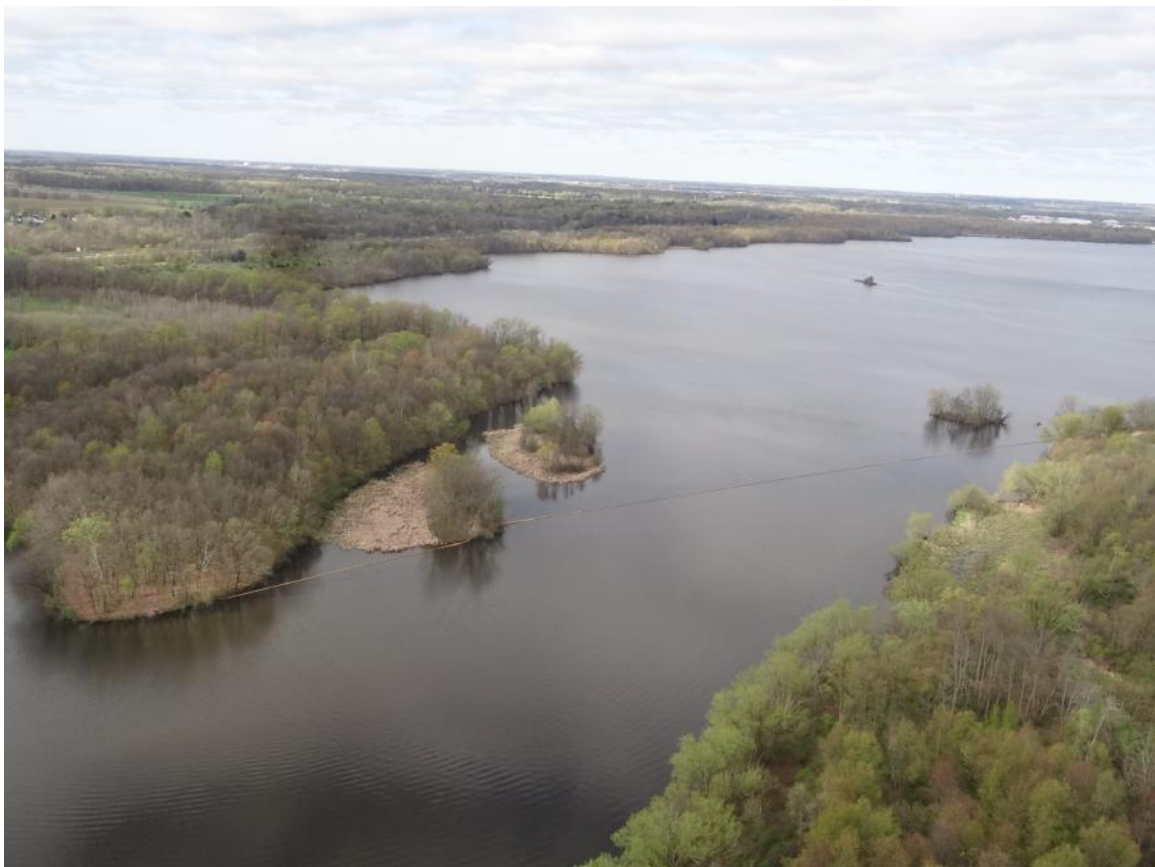
**28. Control Point E4, no sheen observed.**

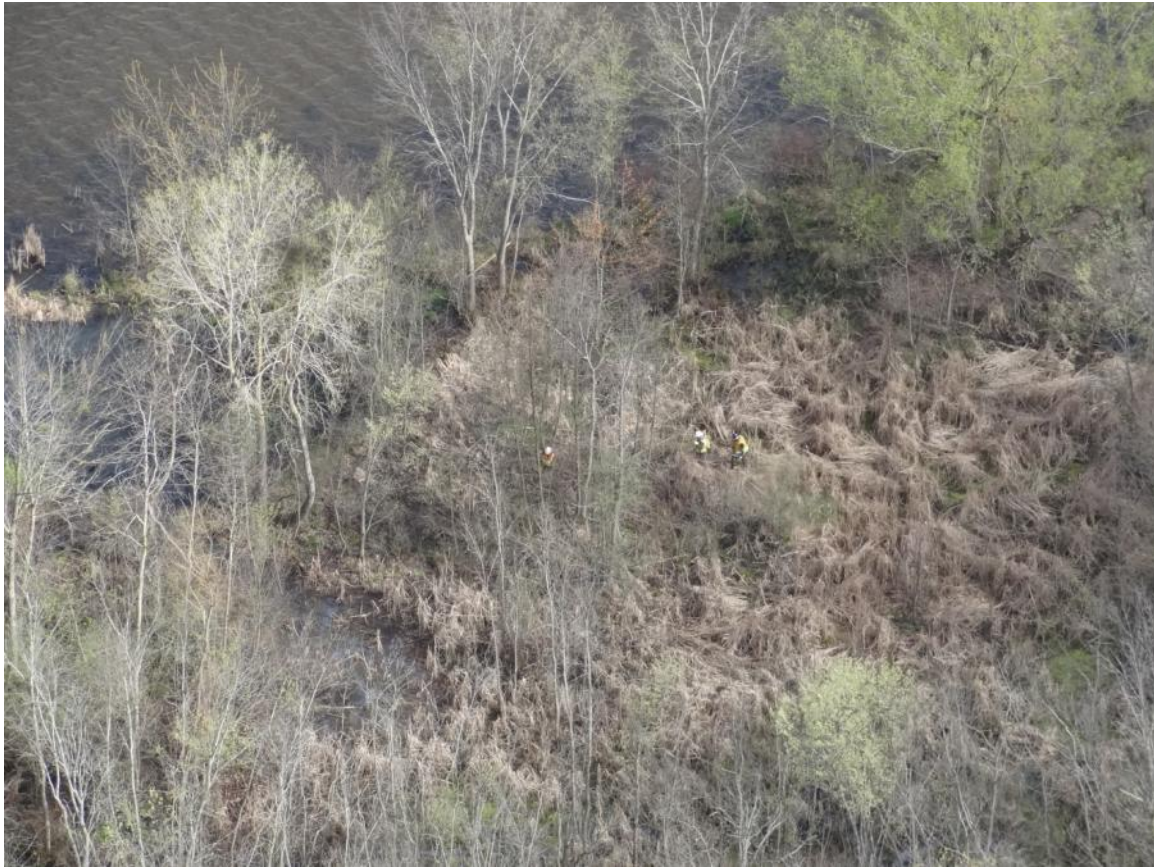
**29. Morro Lake MP39.5 LDB SORT crew observed.**
